AIRCRAFT TECHNICAL LOGS

Section 4. PROPELLER

PROPELLER LOGBOOK

Propeller Model D3A34C401-C

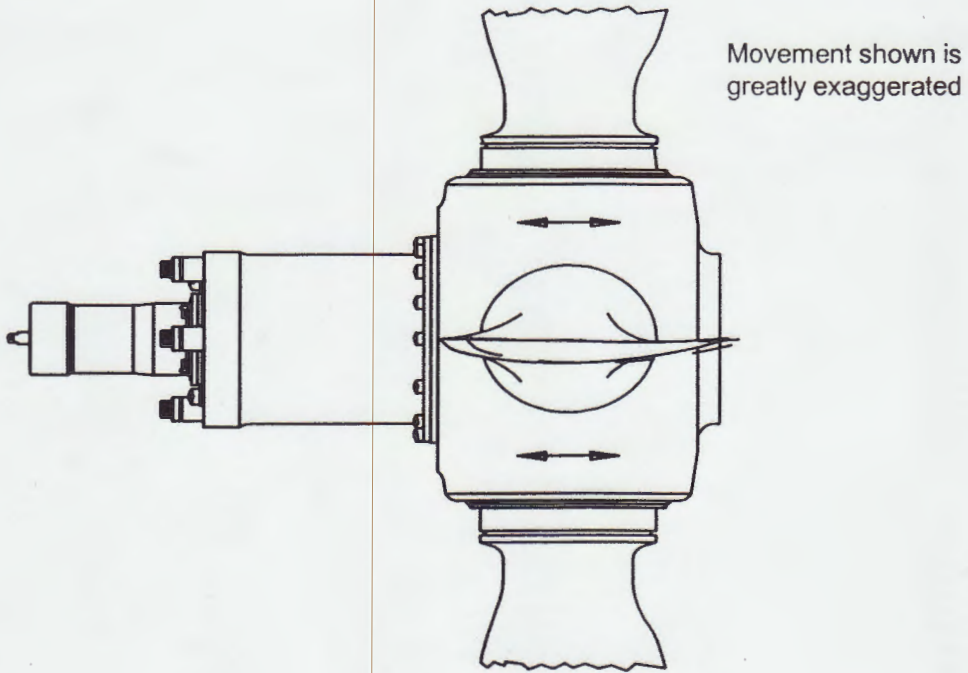
Figure 1 - Blade Shake

Blade shake is defined as the tendency for the propeller blades to wobble slightly when the tip is physically moved by hand (lead edge to trail edge; see Figure 1). This tendency is a natural result of the fabrication of parts within the McCauley retention system. While accumulation of tolerances is measured in thousandths of an inch, it must be remembered that both the parts causing blade shake, and the pivot point about which the blade rotates, are near the blade root. As a result, very small differences at the blade root will be magnified many times when measured at the tip. Total maximum allowable movement up to 1/8 or .125 inch (3.13mm) is considered normal. C1100 series propellers may have a maximum movement of 3/16 or .1875 inch (4.7mm).

Normal blade shake (less than maximum allowable movement) is no cause for concern, as it disappears during propeller rotation due to the high centrifugal forces acting on the blades (20,000 - 45,000 lbs.).

If, however, blade shake exceeds maximum movement allowable, it should be reduced, *when convenient*, by inserting shims in the blade assembly by an FAA-approved propeller repairman. In many cases, adjustment can be performed with the propellers still installed on the aircraft. Refer to the appropriate McCauley Service Manual for instructions on installing shims.

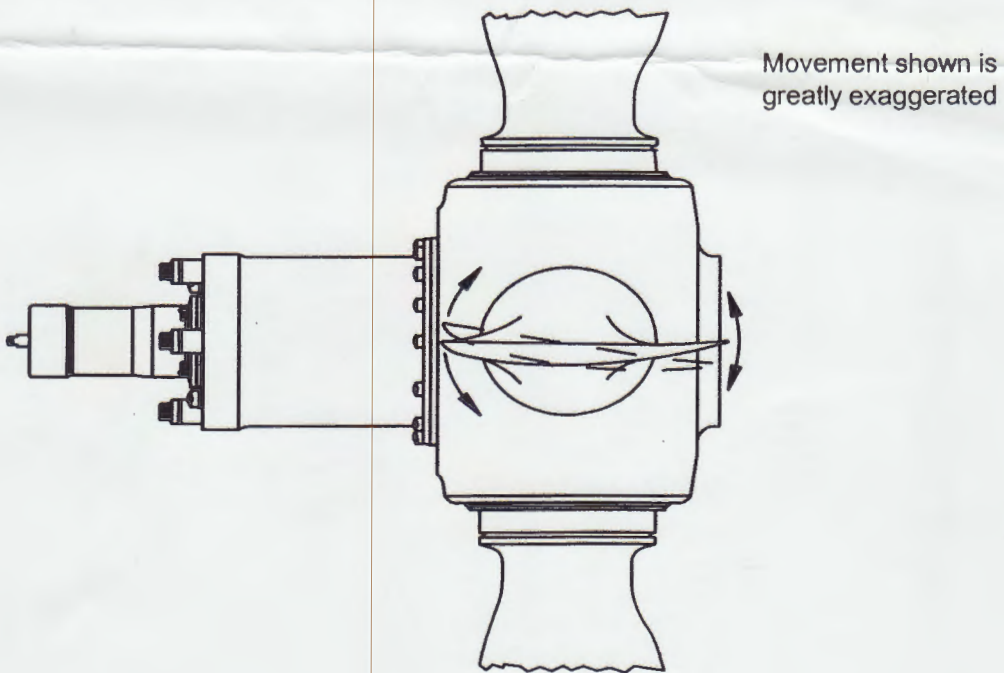
Figure 2 - Blade Twist

A. The first type is "rotational play" and can be defined as the sum total of rotational movement a propeller blade allows when moved by hand around its axis of rotation (see Figure 2). This movement is, to a limited degree, considered normal and should not be cause for concern. Please note that, while a specific rotational movement limit is no longer given, all blades in a propeller should have about the same amount of "rotational play". If the *difference* in rotational play between two blades is beyond 1.0 degree, uneven internal wear and/or damage is the possible cause.

(For example, rotational movement of No. 1 blade measures 1.2 degrees, and No. 2 blade measures 2.3 degrees. This would be considered excessive since their difference is beyond 1.0 degree.) The cause of the excessive difference should be determined by an FAA approved propeller repairman or international equivalent at the next opportunity.
